Engineered
Corrosion
Solutions

Corrosion Solutions for Fire Sprinkler Systems

Dry Pipe and Preaction System Solutions

Wet Pipe System Solutions

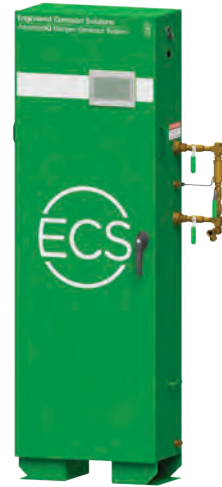
Stand Alone Nitrogen Generator
AG-6500 | AG-11000 | AG-18500 | AG-22500
Up to 22,500 Gal.

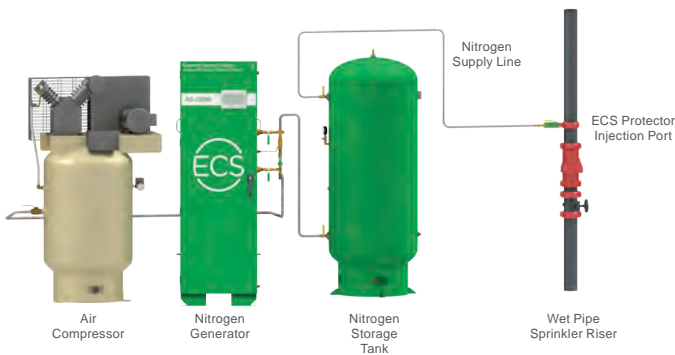
Sprinkler System with Nitrogen Generator
(Vent placed at furthest point on the system)

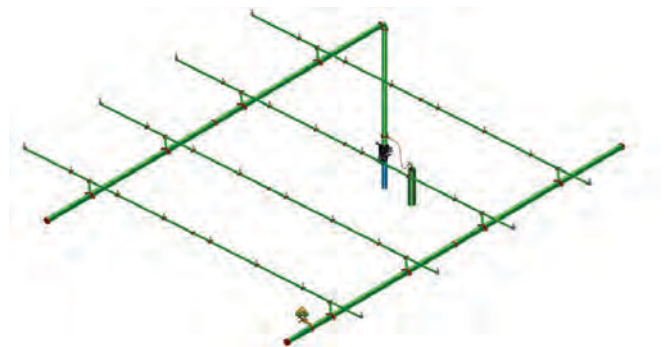
Sprinkler System with Nitrogen Cylinder
(Vent placed at furthest point on the system)

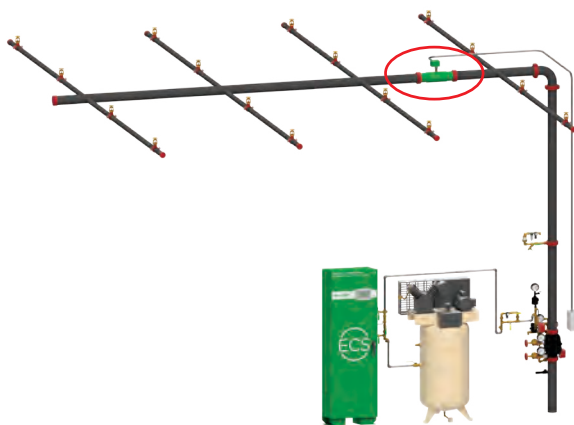
Dry Pipe/Preaction Sprinkler System

- Install ILD on a horizontal portion of a feed main at low elevation near riser.
- On existing systems separate main at fitting and inspect pipe for small pools of trapped water.

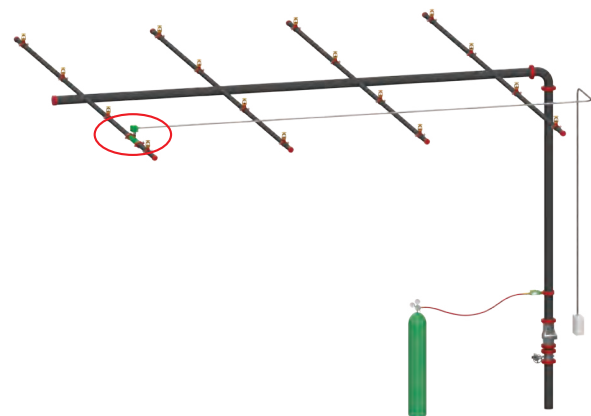
Wet Pipe Sprinkler System

- Install ILD on a branch line near the highest elevation of the system, or adjacent to area where trapped air is likely to collect.
- On existing systems separate branch line at fitting and inspect pipe interior for signs of air/water interface.

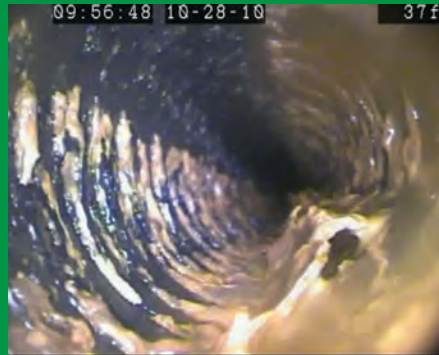
Branch line at 37ft with significant corrosion deposits, clear air-water interface

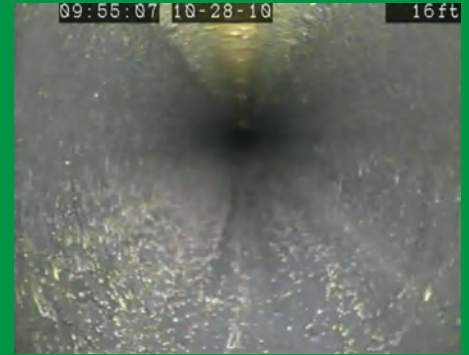
Same branch line at 16ft with no corrosion, water filled with no air-water interface

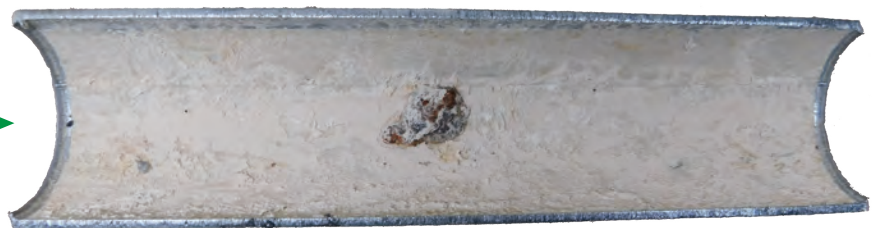
Before media blasting →

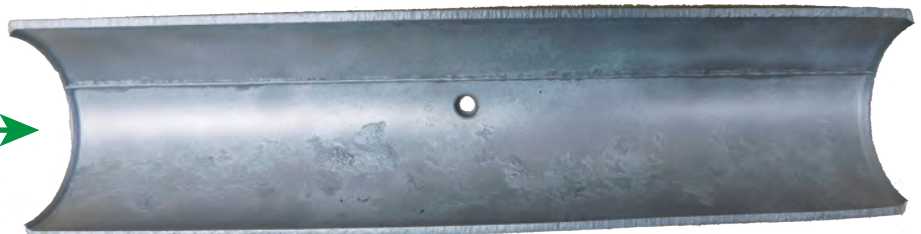
After media blasting →

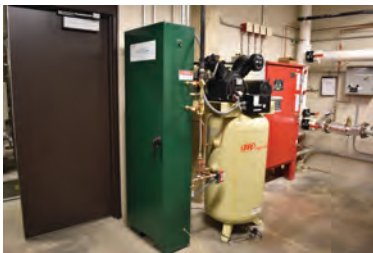
Nitrogen Generator installed in Riser Room

In the fall of 2017 Wayne Automatic elected to install an ECS Nitrogen Generator after struggling with poor performance of the Dry Air Pac™ for years. This picture (right) was taken before commissioning prior to the line being cleared of ice during a quarterly inspection. Frost and ice had formed near the entry to the freezer area in the air line. There was an approximate 20% blockage in the air supply line before commissioning of the nitrogen generator.

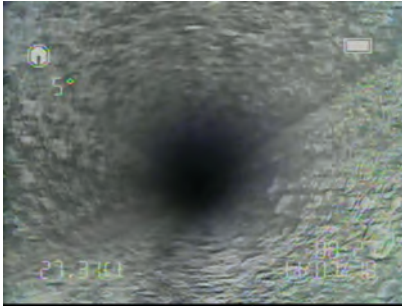
The original galvanized piping of zone 4 did not contain any trapped water or evidence of significant corrosion.

Zone 4: 4" Main – Original Galvanized Pipe

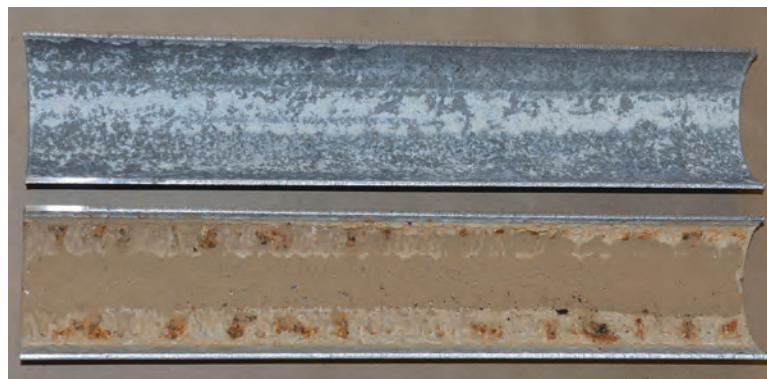
Internal corrosion as received, pipe sample from 2014 assessment

- Large amounts of trapped water present in this piping, combined with the compressed air pressure maintenance gas, resulted in localized corrosion of the galvanized pipe, eventually resulting in leaks.
- Pipe samples taken from the systems identified localized corrosion of up to 69.2% pipe wall loss.
- Only metal loss consistent with oxygen corrosion was observed.
- Partial replacement of feed main piping on five (5) of the systems was performed.

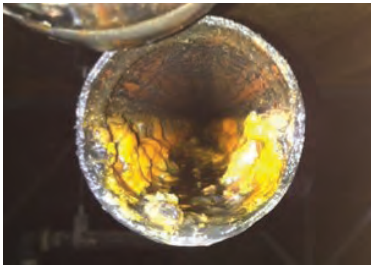
Corrosion at Air/Water Interface
