Corrosion Management for Sprinkler Systems

Existing Facilities

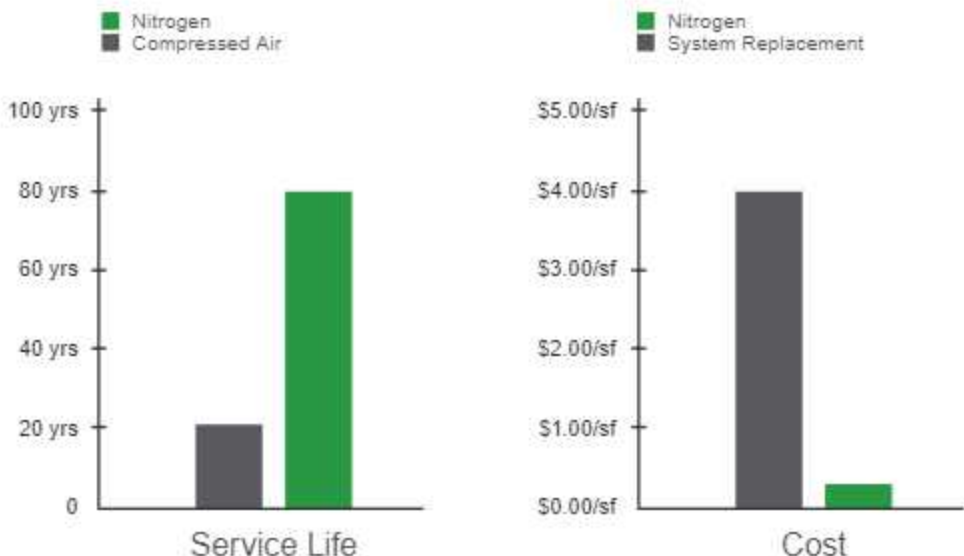
98% Nitrogen: >4x Service Life Multiplier

Cost of Full System Replacement: \$3.00 - \$5.00 per sf

Average Dry System Service Life: 20 years

Cost of Nitrogen Implementation: \$0.20 - \$0.40 per sf

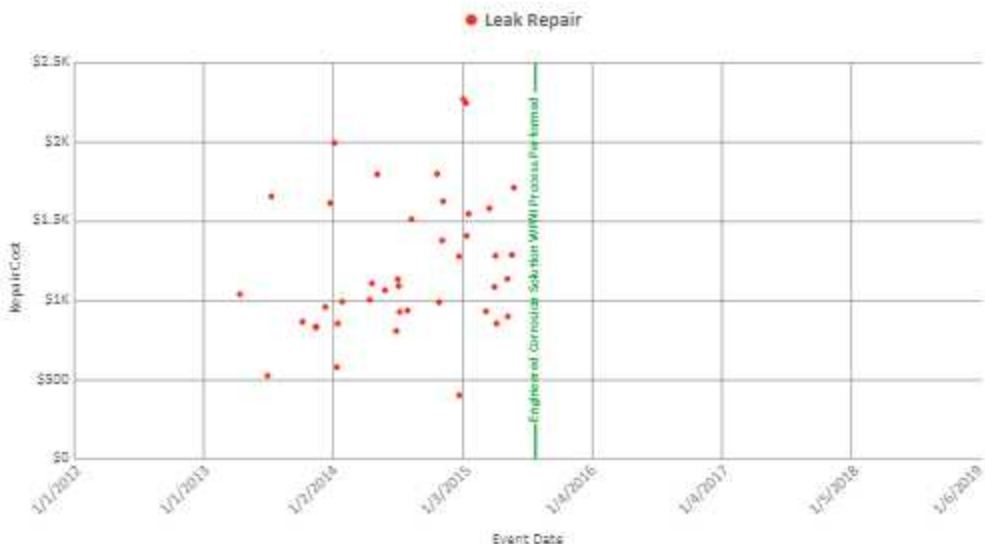
Big Box Store – Wilmington, NC

Years in service: 26

Pinhole leak repairs: 41

Total repair cost: \$49,929

WPNI performed on: 8/11/2015

Cost of WPNI implementation: \$12,000

Pinhole leaks since WPNI: 0
